**Flood Control Project Maintenance
Levee Inspections**

Fall 2010 Levee Maintenance Deficiency Summary Report

Reclamation District No. 0544 Upper Roberts Island

Levee Inspection Report By Mile - Fall 2010

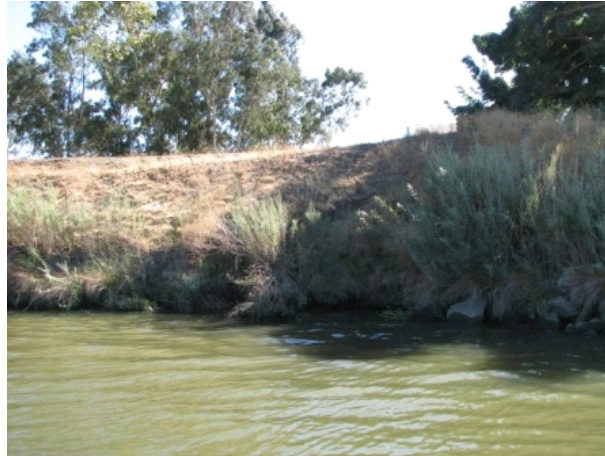
Levee Mile Report Line	3
Start Levee Mile	0.41
End Levee Mile	0.45
Location	Water Side
Category	Supplemental
Item	DWR Erosion Survey

Upstream view of site where a 4-foot vertical scarp has occurred.

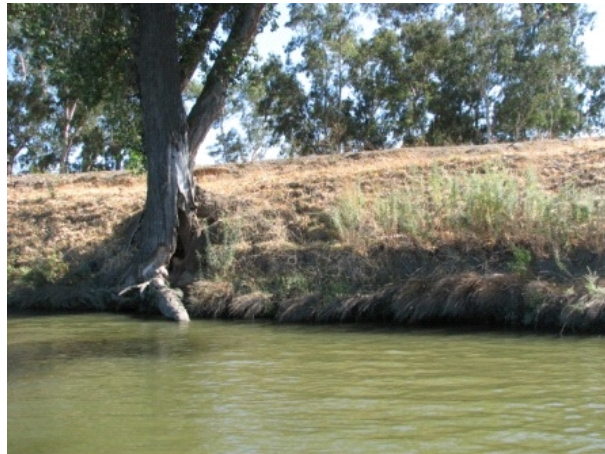
Levee Mile Report Line	3
Start Levee Mile	0.41
End Levee Mile	0.45
Location	Water Side
Category	Supplemental
Item	DWR Erosion Survey

Upstream view of site where undermining of the slope has occurred.

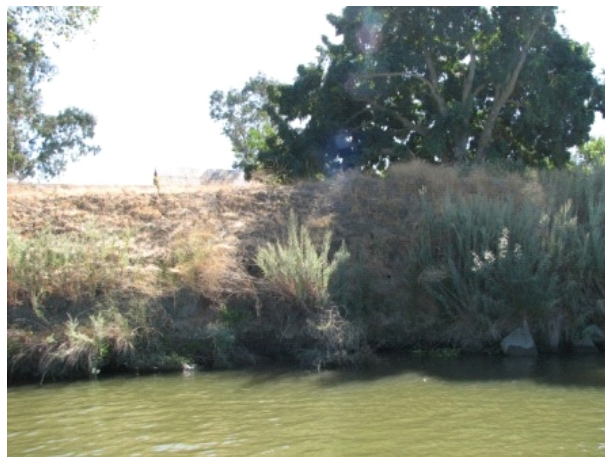
Levee Mile Report Line	3
Start Levee Mile	0.41
End Levee Mile	0.45
Location	Water Side
Category	Supplemental
Item	DWR Erosion Survey

Front view of site.

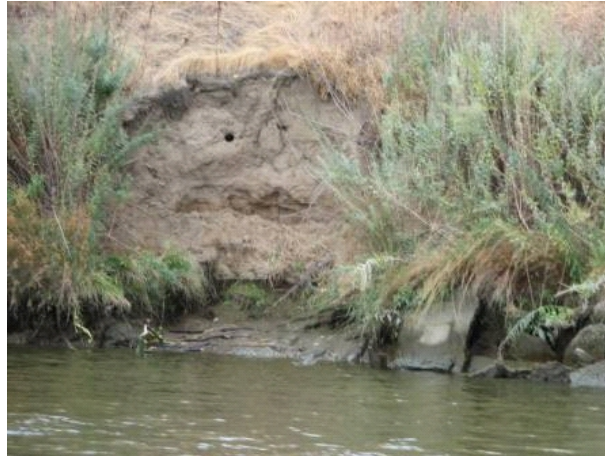
Levee Mile Report Line	3
Start Levee Mile	0.41
End Levee Mile	0.45
Location	Water Side
Category	Supplemental
Item	DWR Erosion Survey

Close-up view of a 4-foot long vertical scarp. This photo was taken on 09/30/2009.

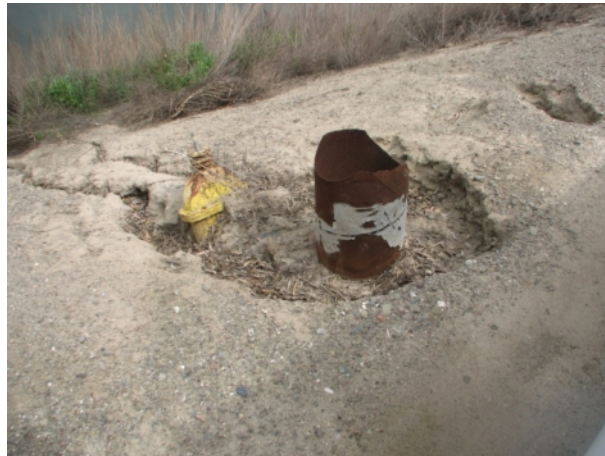
Levee Mile Report Line	8
Start Levee Mile	0.57
End Levee Mile	0.57
Location	Water Side
Category	Earthen Levee
Item	Slope Stability

Erosion around siphon pipe at LM 0.57

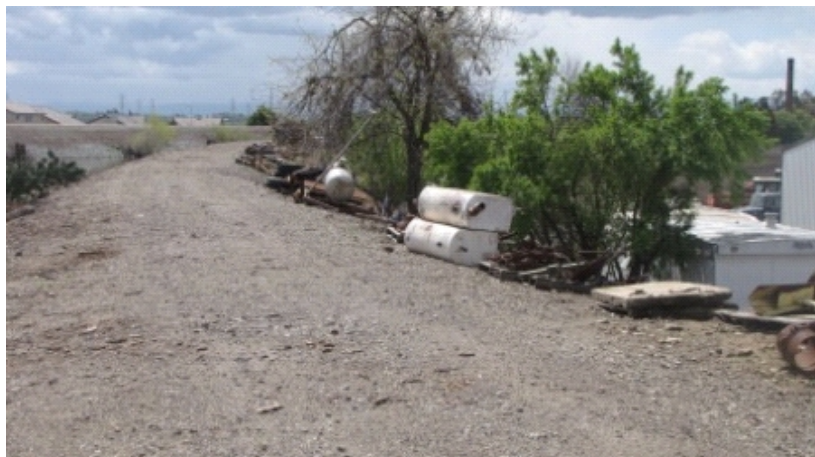
Levee Mile Report Line	30
Start Levee Mile	3.55
End Levee Mile	3.55
Location	Water Side
Category	Earthen Levee
Item	Encroachments

Looking south at equipment stored on landside shoulder.

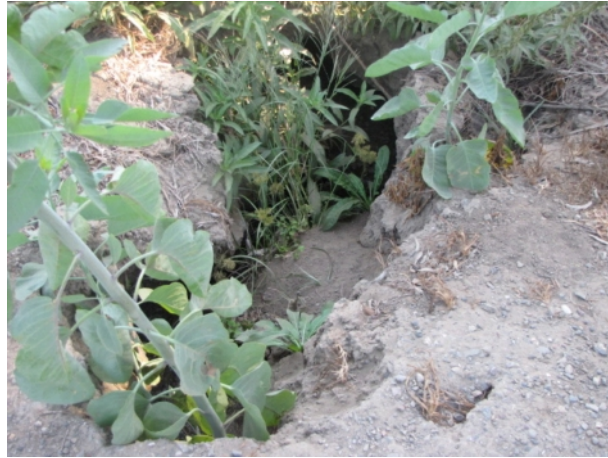
Levee Mile Report Line	34
Start Levee Mile	4.32
End Levee Mile	4.32
Location	Water Side
Category	Earthen Levee
Item	Slope Stability

34	4.32	4.32	Earthen Levee	Slope Stability	WS	U	Repair slope instability. Inspector Comments: Ten inch pipe possible broken pipe.	37.824995 ° -121.314983 °	37.824995 ° -121.314983 °	53 Y

Looking east at erosion on waterside slope and berm cause by leaking 10" pipe.

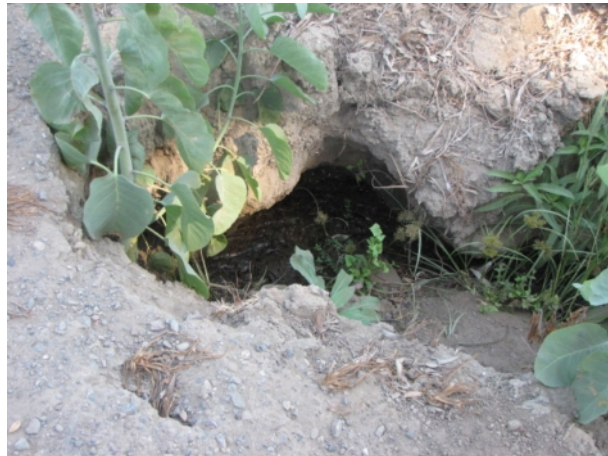
Levee Mile Report Line	34
Start Levee Mile	4.32
End Levee Mile	4.32
Location	Water Side
Category	Earthen Levee
Item	Slope Stability

Looking west at hole on waterside shoulder and slope cause by possible broken pipe.

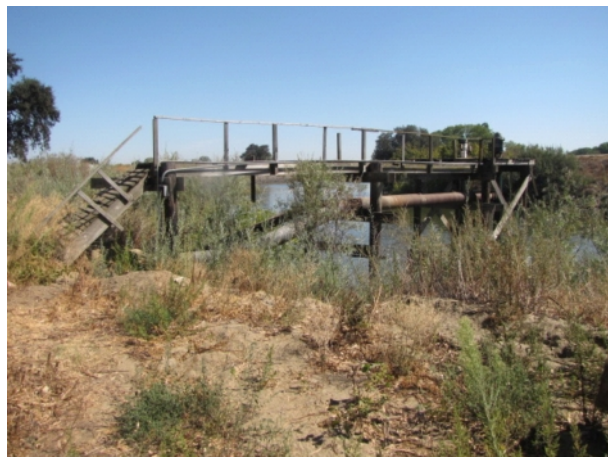
Levee Mile Report Line	34
Start Levee Mile	4.32
End Levee Mile	4.32
Location	Water Side
Category	Earthen Levee
Item	Slope Stability

Looking northwest at pump and platform for 10" possible leaking pipe.

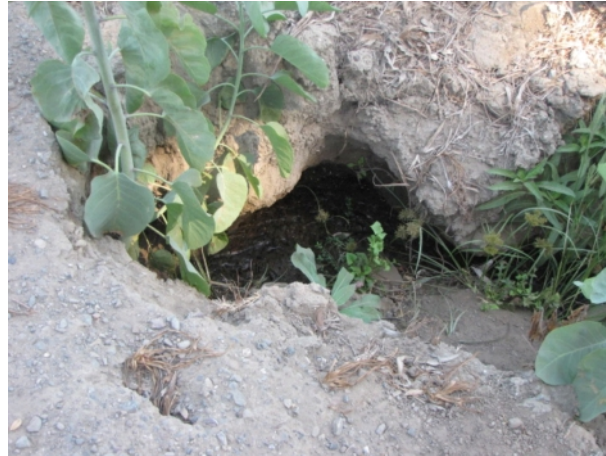
Levee Mile Report Line	34
Start Levee Mile	4.32
End Levee Mile	4.32
Location	Water Side
Category	Earthen Levee
Item	Slope Stability

Looking west at erosion on slope and berm cause by possible broken 10" pipe.

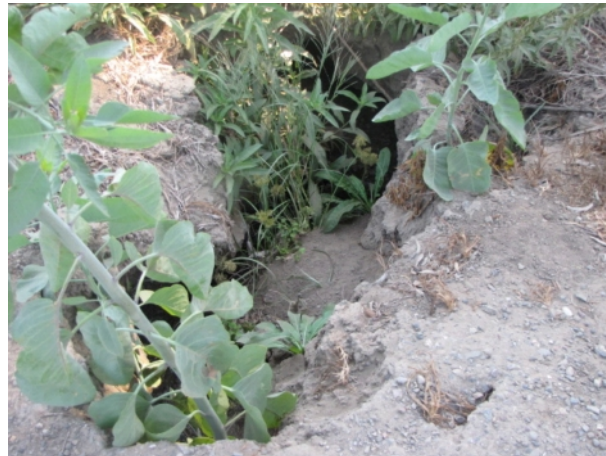
Levee Mile Report Line	34
Start Levee Mile	4.32
End Levee Mile	4.32
Location	Water Side
Category	Earthen Levee
Item	Slope Stability

Looking east at erosion on waterside slope cause by possilbe broken pipe.

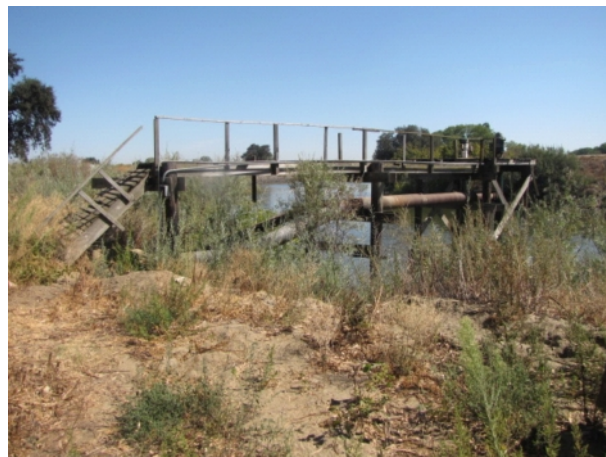
Levee Mile Report Line	34
Start Levee Mile	4.32
End Levee Mile	4.32
Location	Water Side
Category	Earthen Levee
Item	Slope Stability

Looking east at 10" pipe platform.

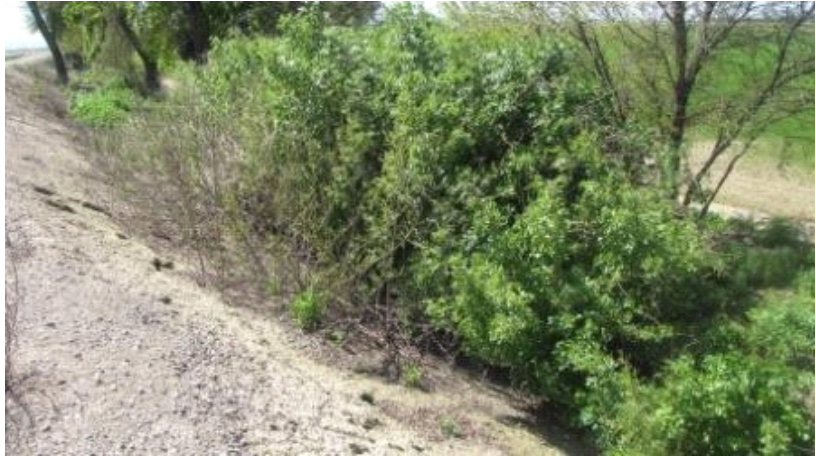
Levee Mile Report Line	37
Start Levee Mile	4.53
End Levee Mile	4.53
Location	Land Side
Category	Earthen Levee
Item	Vegetation

Looking south at elderberries on landside slope and toe.

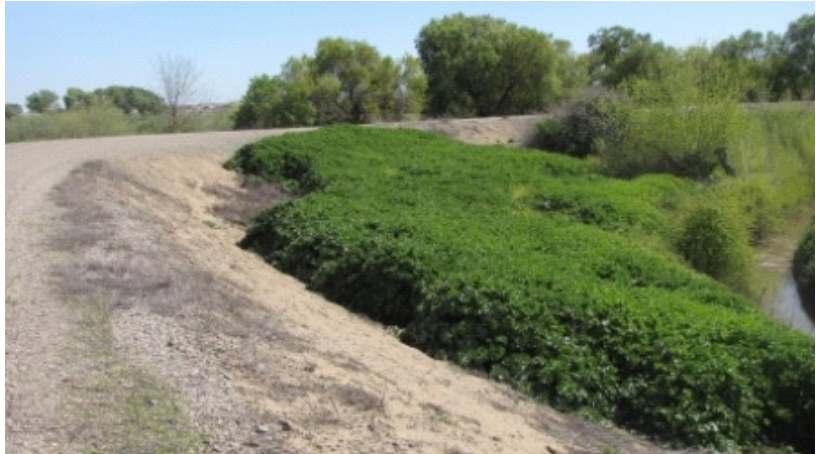
Levee Mile Report Line	45
Start Levee Mile	5.00
End Levee Mile	5.30
Location	Land Side
Category	Earthen Levee
Item	Vegetation

Looking southeast at dense veg. on landside slope and toe.

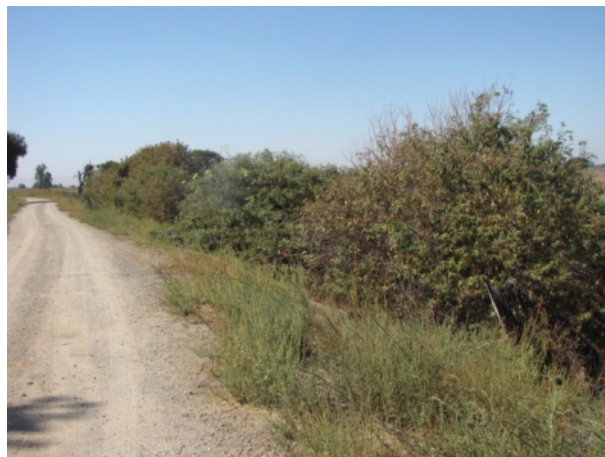
Levee Mile Report Line	50
Start Levee Mile	5.54
End Levee Mile	5.60
Location	Land Side
Category	Earthen Levee
Item	Vegetation

Looking southwest on elderberries on landside slope and toe.

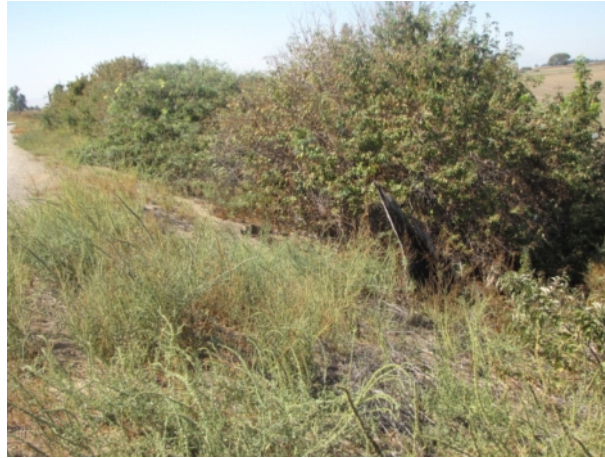
Levee Mile Report Line	50
Start Levee Mile	5.54
End Levee Mile	5.60
Location	Land Side
Category	Earthen Levee
Item	Vegetation

Looking south at elderberries on landside slope and toe.

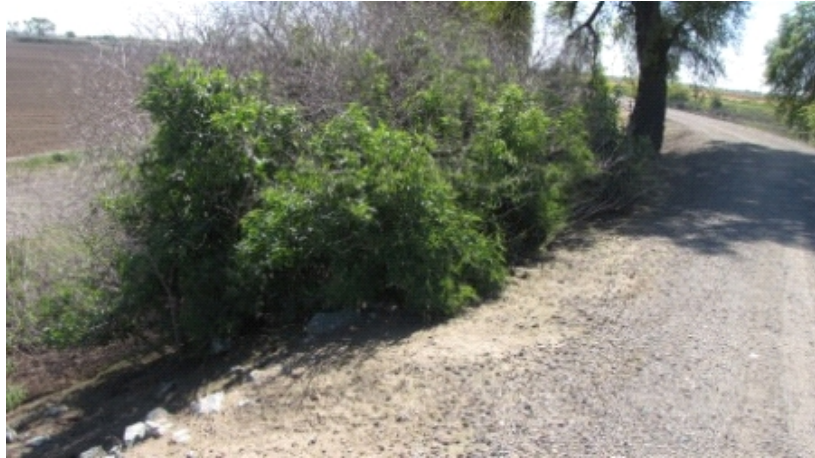
Levee Mile Report Line	3
Start Levee Mile	0.41
End Levee Mile	0.41
Location	Land Side
Category	Earthen Levee
Item	Vegetation

Looking northwest at elderberries on landside slope and toe.

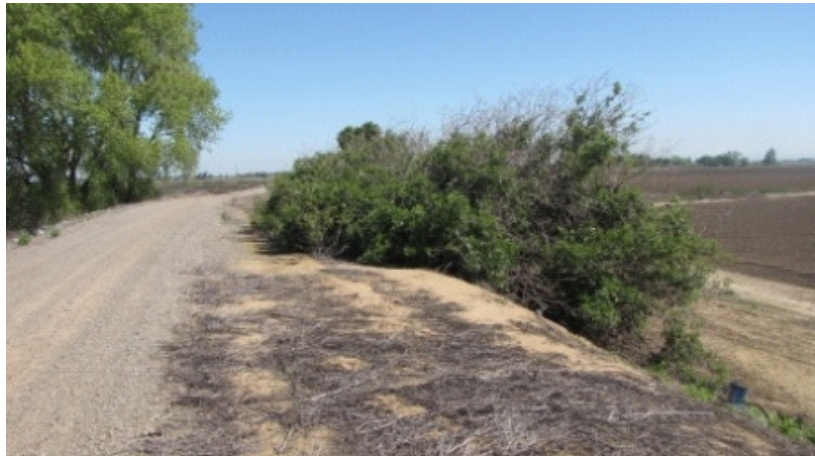
Levee Mile Report Line	8
Start Levee Mile	0.74
End Levee Mile	0.74
Location	Land Side
Category	Earthen Levee
Item	Vegetation

Looking south at elderberries on landside slope and toe.

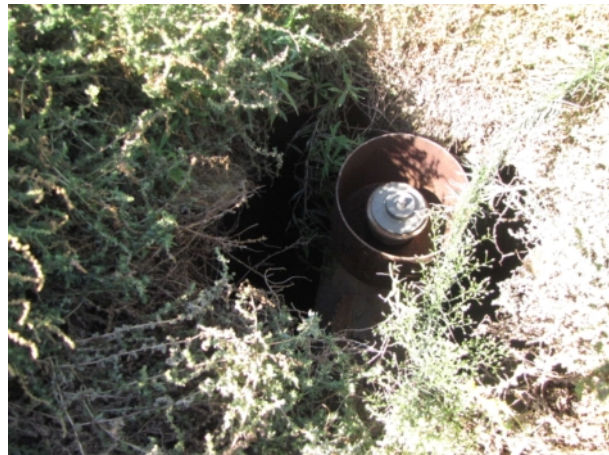
Levee Mile Report Line	9
Start Levee Mile	0.79
End Levee Mile	0.79
Location	Water Side
Category	Interior Drainage & Piping Systems
Item	Erosion Areas

Looking at top of siphon on waterside shoulder with 3' of caving around pipe.

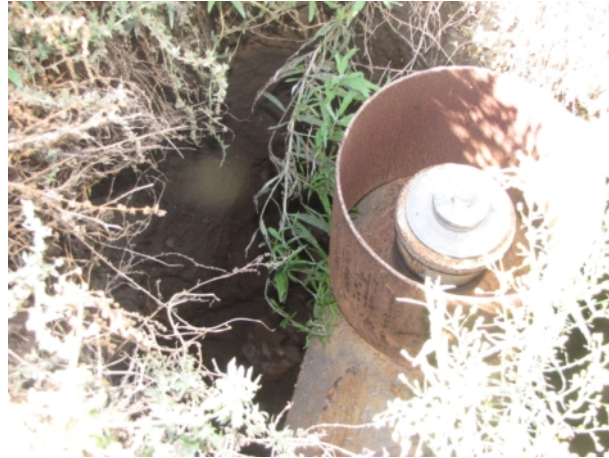
Levee Mile Report Line	9
Start Levee Mile	0.79
End Levee Mile	0.79
Location	Water Side
Category	Interior Drainage & Piping Systems
Item	Erosion Areas
Looking at caving around 10" siphon pipe on waterside shoulder.	
richard_f_20101123_161.jpg

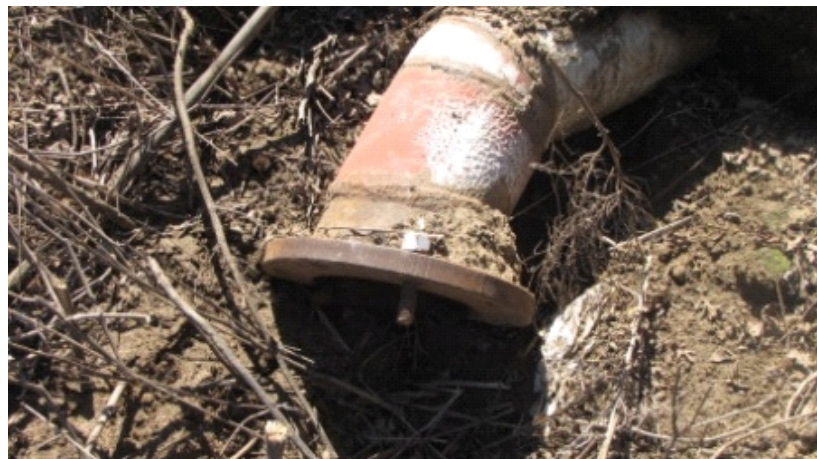
Levee Mile Report Line	16
Start Levee Mile	1.40
End Levee Mile	1.40
Location	Land Side
Category	Earthen Levee
Item	Encroachments
Looking east at pipe on landside slope.	
richard_f_20100921_155.jpg

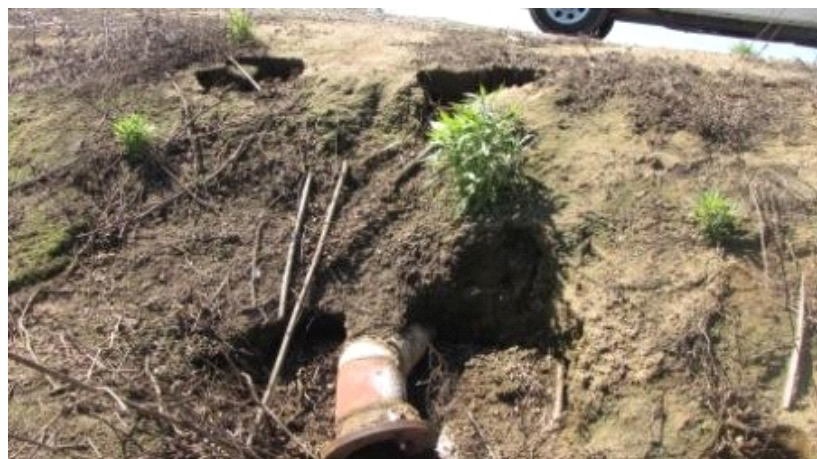
Levee Mile Report Line	16
Start Levee Mile	1.40
End Levee Mile	1.40
Location	Land Side
Category	Earthen Levee
Item	Encroachments
Looking east at pipe and erosion just above pipe on landside slope and shoulder.	
richard_f_20100921_156.jpg

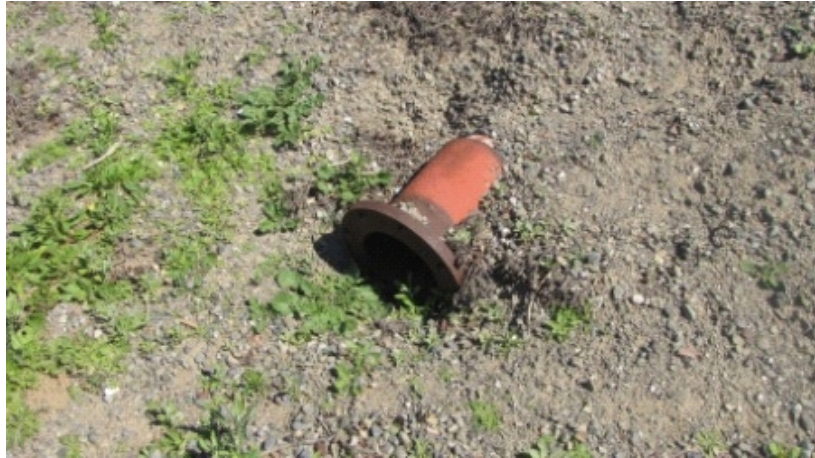
Looking west at east end of pipe on waterside slope.

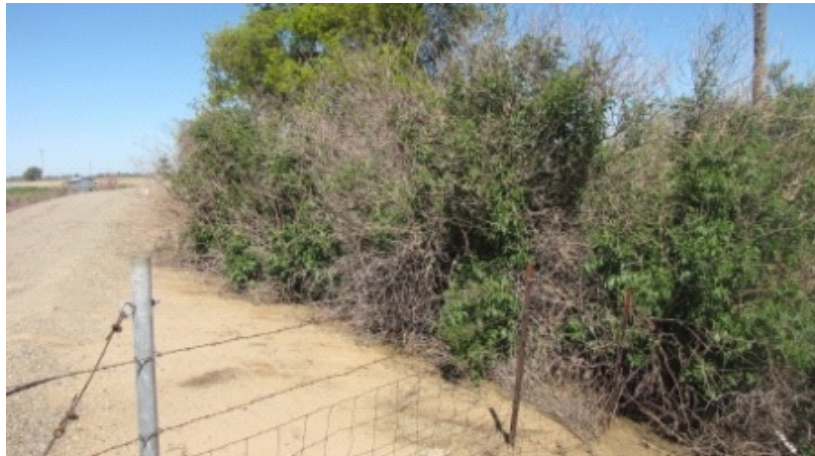
Levee Mile Report Line	17
Start Levee Mile	1.41
End Levee Mile	1.41
Location	Land Side
Category	Earthen Levee
Item	Vegetation

Looking south at elderberries on landside slope and toe.

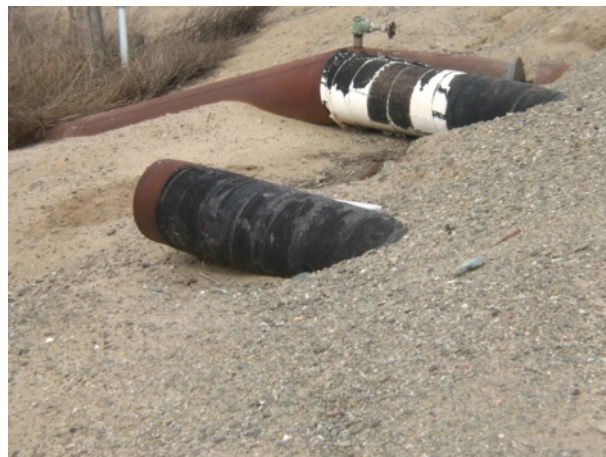
Levee Mile Report Line	32
Start Levee Mile	2.65
End Levee Mile	2.65
Location	Crown
Category	Earthen Levee
Item	Encroachments

Abandoned pipe at LM 2.65 landside view

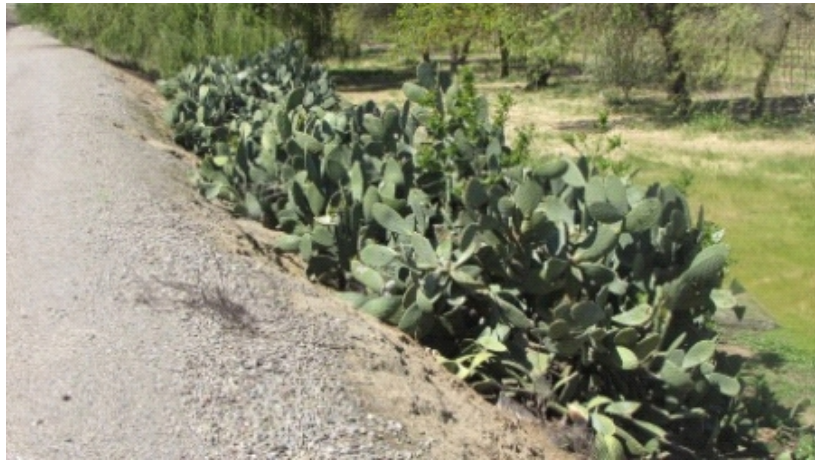
Looking southwest at overgrown cactus on landside slope.
